CONDITION SURVEY

**GLATTON VILLAGE HALL
HIGH HADEN ROAD
GLATTON
HUNTINGDON
PE28 5RU**

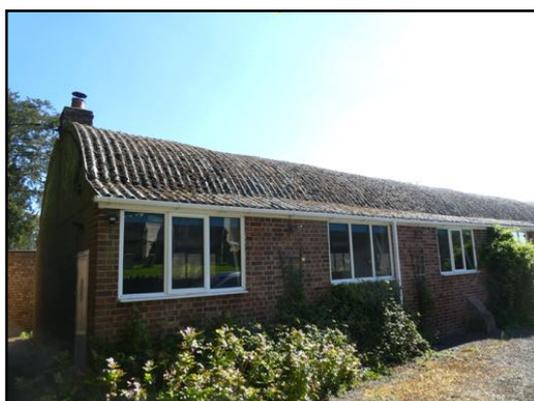
The building is constructed around a semi-circular steel frame, with the steelwork still partly exposed and visible internally as well as above the suspended ceiling. This rounded frame will originally have been clad in corrugated asbestos fibre-cement sheeting, although the semi-circular structure was extended

outwards at eaves level and clad in brick, presumably when it was converted into its present use. Above eaves level it remains clad with corrugated asbestos fibre-cement sheeting to act as a roof covering. The front and rear elevations are built in brick and these are probably original.

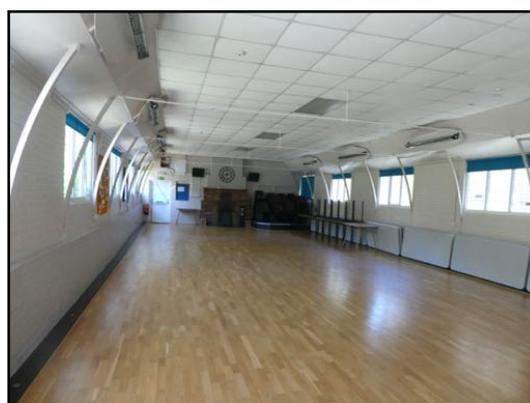
built to the bases of the left- and right-hand walls. A bitumen damp proof course is in place beneath the floor.

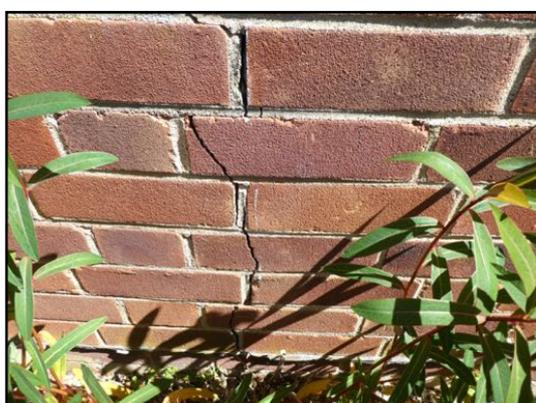
The building is exhibiting signs of previous movement, although appears currently stable. There is some cracking which has opened up within the external brickwork, notably towards the front of the left-hand elevation and I understand this has opened up within the last five years or so.

There is also some outward movement to the right-hand wall where the brickwork has pushed outwards on top of the damp proof course, with notable distortion adjacent to the internal spinal wall, within the ladies WC. The floor in

this area has settled and there is evidence of settlement to the main internal wall, with notable distortion around the door frames.

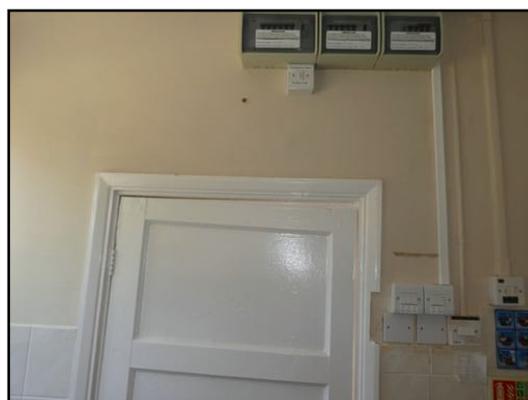
The amount of movement exhibited thus far is not considered to be serious, but may be progressive. The British Geological Survey Map for England and Wales shows this area as consisting of clay and this is susceptible to subsidence and settlement. There are very tall trees positioned close to the rear of the building and these could cause the clay soil beneath and around the foundations to shrink, although these trees are quite mature and may well have been present before the building was

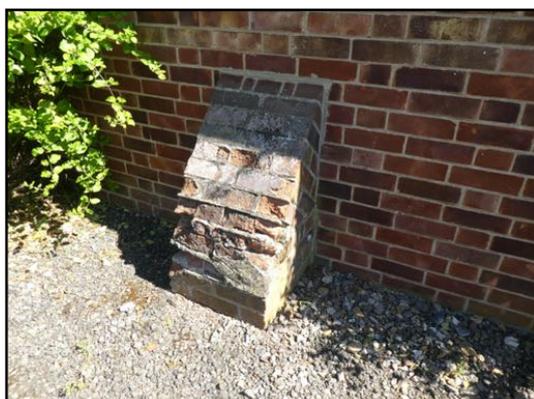
The steel frame shows no signs of significant disrepair. The brickwork is in a generally satisfactory condition, although cracks should be repaired and repointed. The external buttressing brick sections have suffered frost attack and subsequent spalling and fracturing and this problem has

been exacerbated by the fact that they have been repointed using a

brittle cementitious mortar which is stronger than the brickwork itself. The amount of support they provide is rather limited although the brickwork needs repair, with fractured bricks replaced and a softer lime mortar used to repoint.

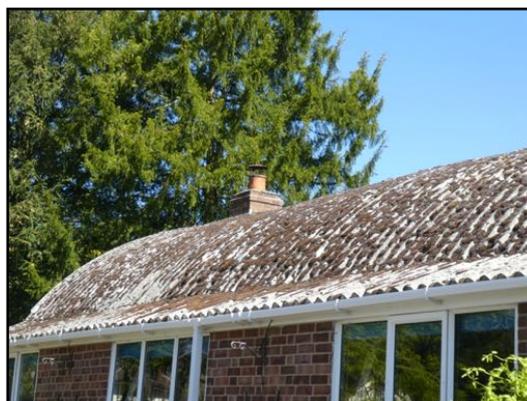
These corrugated asbestos roof sheets have approached the end of their useful life. The roof sheets are leaking in some areas, including to the rear left-hand corner and most notably above the kitchen where rainwater ingress has caused significant damage to the ceiling beneath. Patch repair would not be viable and if the building is to be retained the roof coverings need to be completely stripped and renewed within the next few years.

As the roof sheets contain asbestos this will need to be done by a specialist company and all necessary precautions will need to be taken. This will probably involve the erection of scaffolding to carefully lift and remove the sheets from the structure and the loadbearing capacity of the steel frame will then need to be carefully assessed by a Structural Engineer prior to the installation of replacement roof coverings. The replacement coverings will need to be of similar materials (although not containing asbestos), being corrugated roof sheets of a similar weight so as not to overload the steel frame which was designed for the current coverings.

This will be a considerable operation and quotes for this work will need to be obtained in order that you can assess the feasibility of the work and viability of the building.

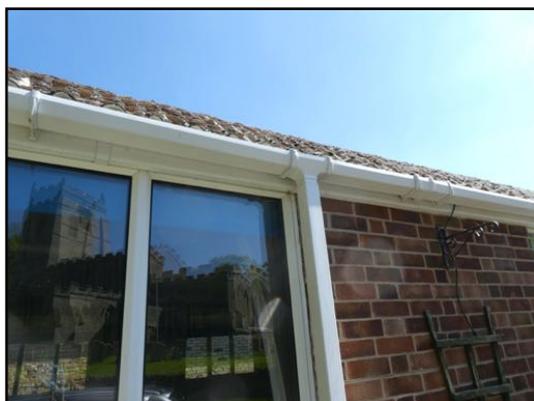
These rainwater fittings appear to have been renewed in recent years and show no signs of disrepair. The downpipes discharge rainwater below ground level.

appears necessary. Some slight realignment of the gutter and downpipes to the right-hand side is needed, although generally these rainwater fittings only require normal maintenance including regular clearing of blockage and debris.

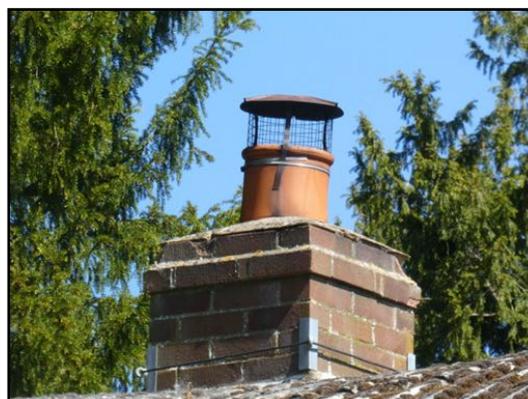
This chimney is structurally stable, although the mortar flaunchings to the top of the chimney stack

have cracked and perished and this is leading to rainwater ingress. It is also causing the chimney pot to be loose and insecure. These mortar

flaunchings need to be replaced and the chimney pot set in the new flaunchings.

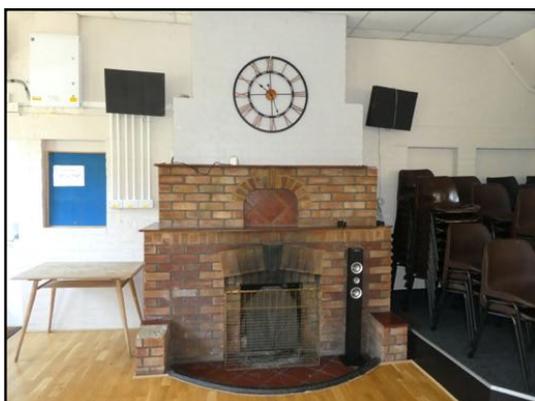
The fireplace itself is damaged and the flue is not lined internally, although it is unlikely that this fireplace has been used for many years or will be used again in the future. The hearth is badly damaged and the fireback is also

damaged and if it were to be used it would need to be partially rebuilt. If it is to be retained but not used I would recommend the mortar flaunchings are replaced and then the opening is covered over for safety reasons.

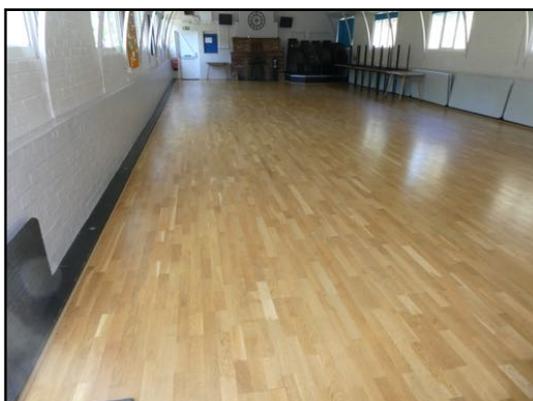
The floor is of a solid construction, probably built in concrete and with a cement screed although the floor is concealed by internal floor coverings.

The floor in the main hall has been recovered with a laminate floor covering in recent years. I am told that underneath this

there are wooden floorboards although these were continually moving and popping nails and so the floor had to be overlaid for safety reasons.

The floor has clearly settled over the years, with the floor in the ladies' toilet being notably uneven. This has caused gaps between the sealed floor and the right-hand wall and the previous movement and popping of the floorboards suggests further settlement. This is due to general slight structural movement, with varying moisture content in the supporting clay soil beneath and although this is not representative of a serious structural concern it does represent slight ongoing movement. Currently, the floors require some maintenance and resealing although there is no evidence of significant disrepair.

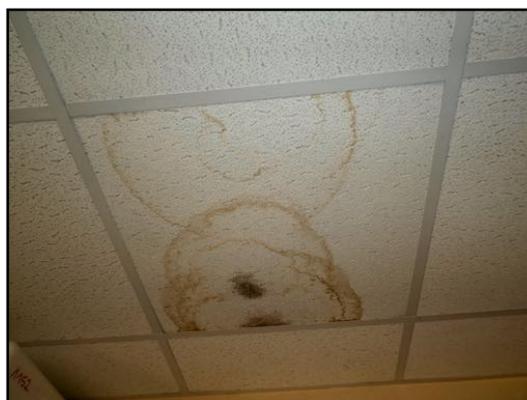
The suspended ceiling is in a reasonable condition although will require ongoing maintenance, including where rainwater ingress has caused dampness and individual tiles need to be replaced. This is currently evident to one tile in the kitchen which is damp and damaged due to rainwater ingress above through a hole in the roof.

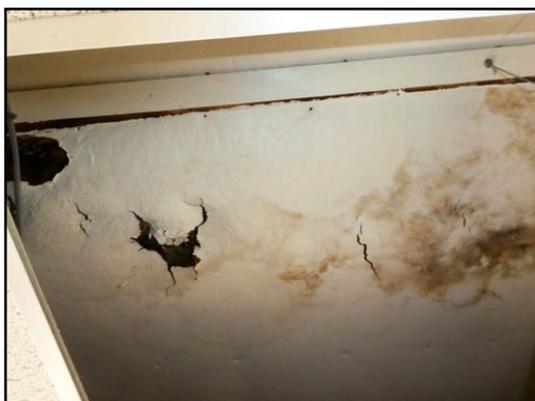
This hole in the roof has also caused significant damage to the asbestos fibreboard ceiling above and this needs to be replaced. Elsewhere these asbestos ceilings are in a reasonable condition commensurate with age, but replacement of ceilings containing asbestos fibres is an expensive and difficult

operation which will need to be undertaken by specialists. Again, quotes for this work will need to be obtained at the same time as the quotes for the replacement of the asbestos roof sheets and this work also means the economic viability of the building is of some concern.

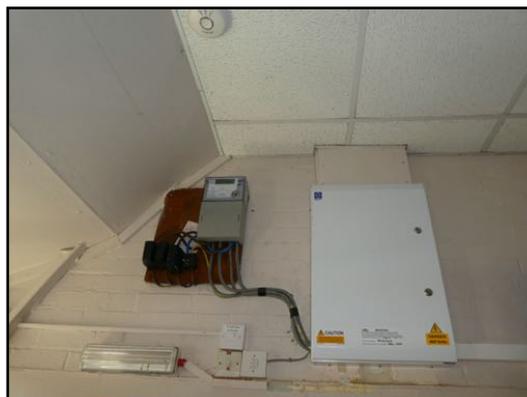
I understand the electrical installations were checked and made safe last years although I understand the electrical installations as a whole do not comply with current standards.

The recommended next date of inspection is April 2024 and at that point it is likely that further works will become either necessary or recommended as the overall installation continues to age and deteriorate.

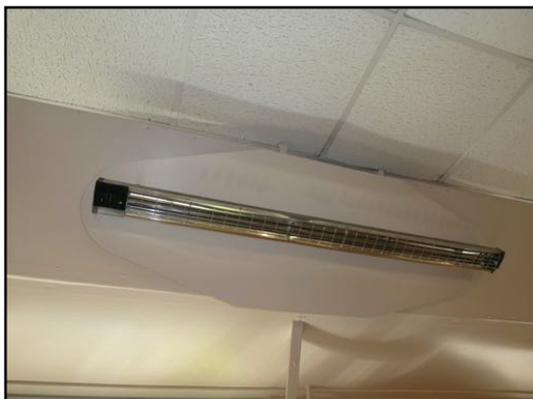
There is no heating within the kitchen or the toilet and the only heating within the main hall is from ceiling mounted electric heaters. These will prove highly inefficient as heat rises and the vast majority of the heat generated will disappear through the roof above. See related comments below.
